# Navajo Abandoned Uranium Mine

# **Site Screen Report**

# **Plot 11 AUM Site**

August 2010

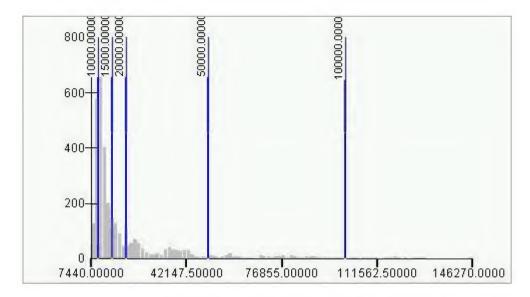
A total of 3,226 gamma radiation measurements were collected from the mine site, ranging from 7,440 cpm to 146,270 cpm. Measurements collected in the vicinity of the waste debris were found at levels up to approximately 120,000 cpm, and near the adits at levels up to approximately 145,000 cpm. The measurements are represented in Figures 1 and 2.

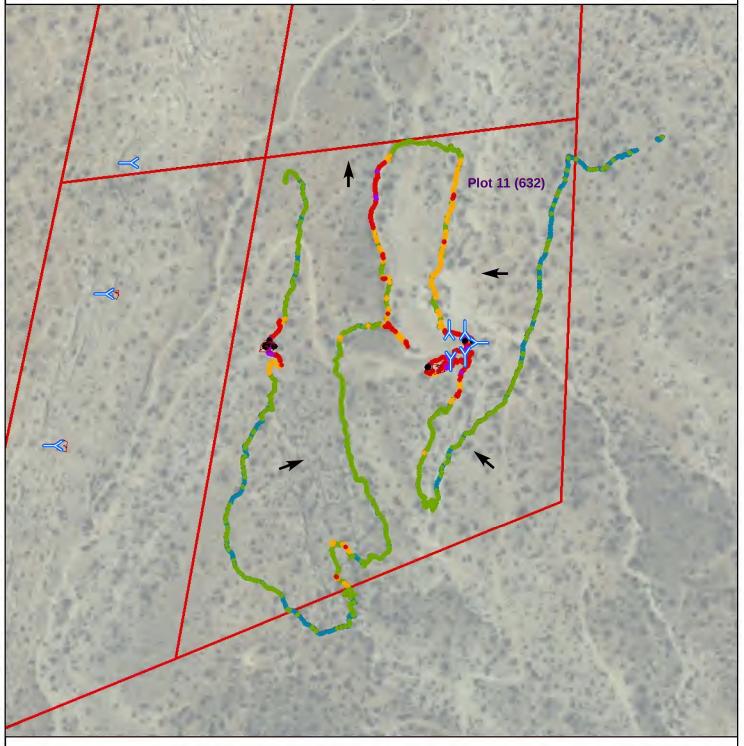
Figure 2 - Gamma Radiation Measurements
Plot 11 (632)
Teec Nos Pos Chapter, Navajo Nation

Gamma survey conducted 06/2010 Measured as counts per minute (cpm)

Average background 9,266 cpm
